## Collapse Accident Site Investigation using Terrestrial LiDAR Surveying

**Abstract :** *A collapse incident is one of the representative disaster accidents. Collapses can occur due to internal defects during the design phase, but other collapses are caused by natural disasters such as typhoons or heavy rainfall, as many structures are exposed to the environment. Therefore, continuous inspections of structures are crucial. Additionally, investigating the causes and damages of already occurred collapse accidents is necessary for preventing recurrence and post-management. However, dealing with and investigating collapse sites is challenging due to the risk of additional collapses. To overcome these challenges, utilizing terrestrial LiDAR is suitable for conducting on-site investigations in secured locations. This study suggests the approach of using terrestrial LiDAR for collapse site investigations. Obtained scan data for the entire collapse site of Jeongja Bridge, which occurred on April 5, 2023, using terrestrial LiDAR. LiDAR measurements were performed at 13 locations to acquire data for the upper and side portions of the bridge. The acquired data was integrated to construct a

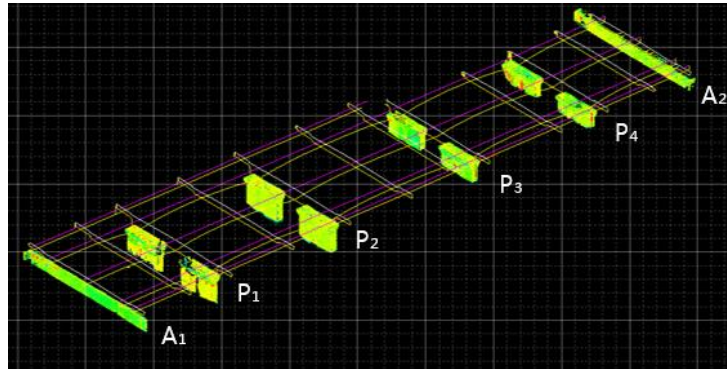
Figure 1: Cross section of bridge model.

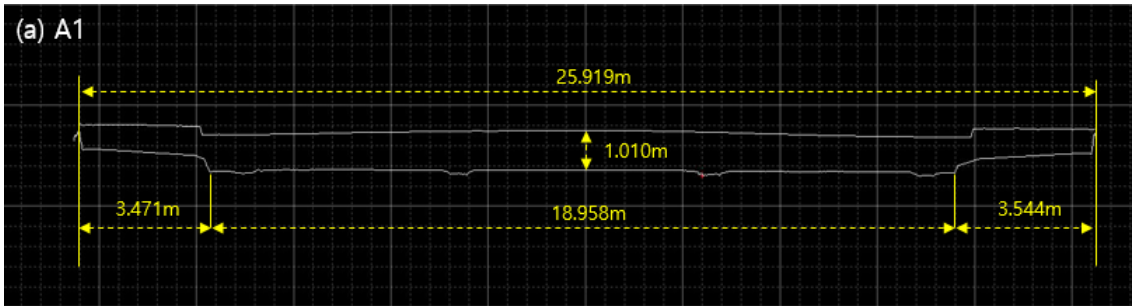
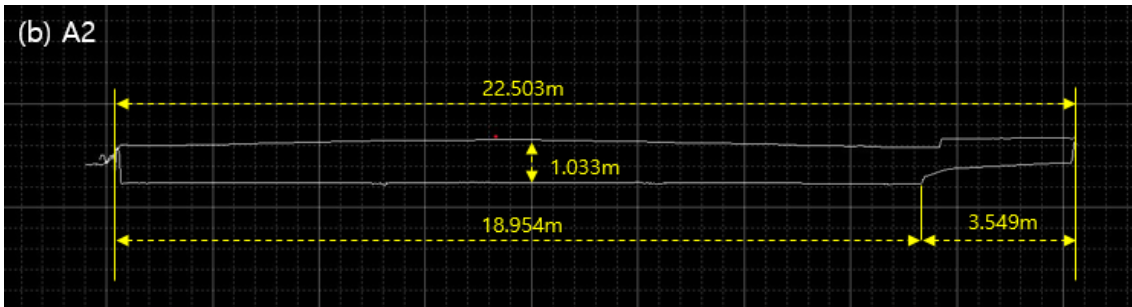
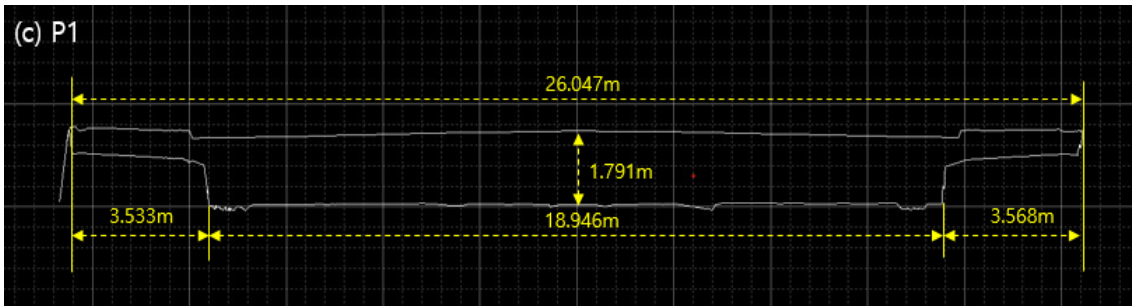
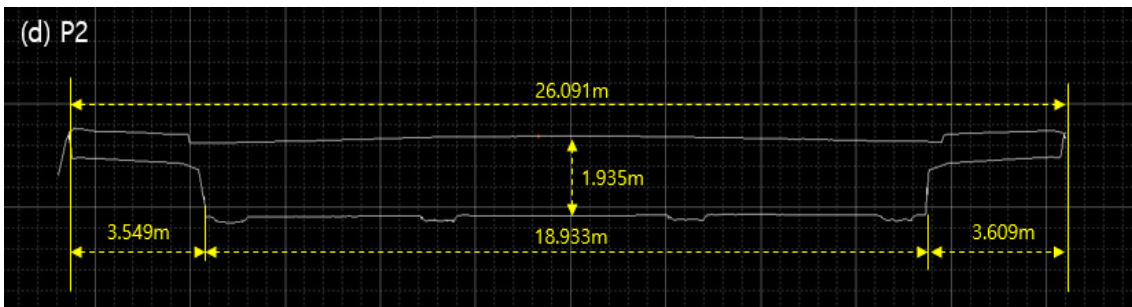
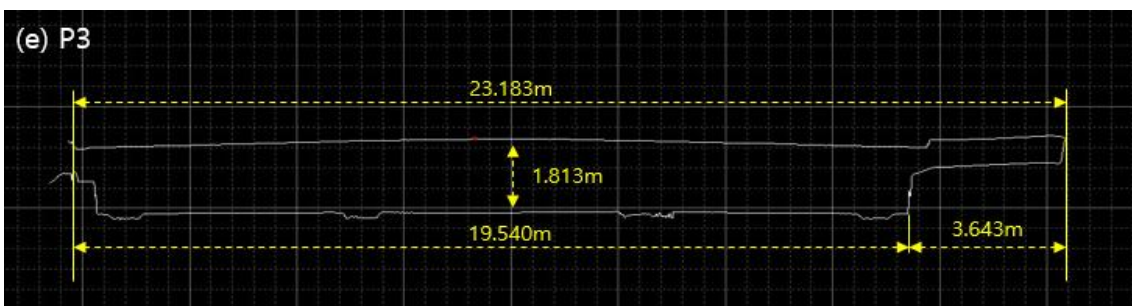
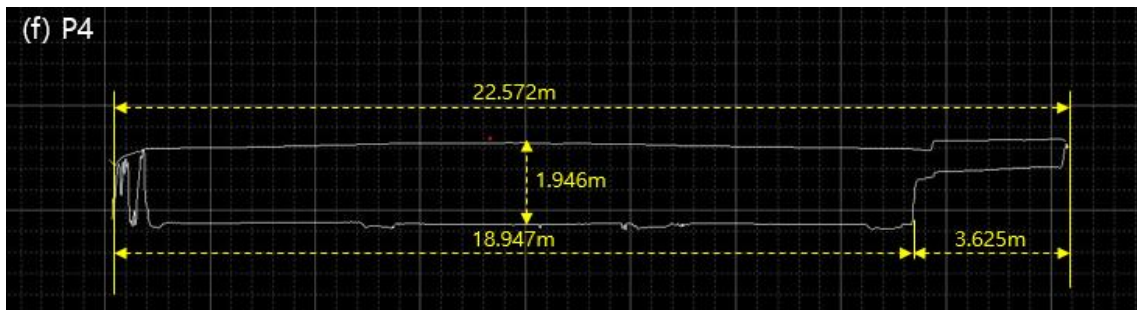
Fig. 4: Observation result of slab condition. (a) Abutment A1. (b) Abutment A2. (c) Pier P1. (d) Pier P2. (e) Pier P3. (f) Pier P4.

In Fig. 3, the pedestrian sections near the collapsed piers P3 and P4, and abutment A2 could not be assessed due to the collapse caused by the accident. However, the pedestrian section on the opposite side showed minimal differences. Observing the cross-sectional measurements of the pedestrian sections, the length on the left side where the collapse occurred, from A1 to P2, ranged from 3.471m to 3.549m. On the right side, from A1 to A2, the length ranged from 3.544m to 3.643m. Compared to the design plan, which specifies a sidewalk length of 3.5m, the left side showed a deviation of approximately -3cm to +5cm, while the right side showed a deviation of approximately +4cm to +14cm. The observed width of the bridge was between 25.919m and 26.091m, showing a deviation of about -2cm to +9cm from the design width of 26.000m. The measurements indicate that the left-side sidewalk, where the collapse occurred, was closer to the design specifications compared to the right side, and the overall width of the bridge exhibited only minor discrepancies from the design.

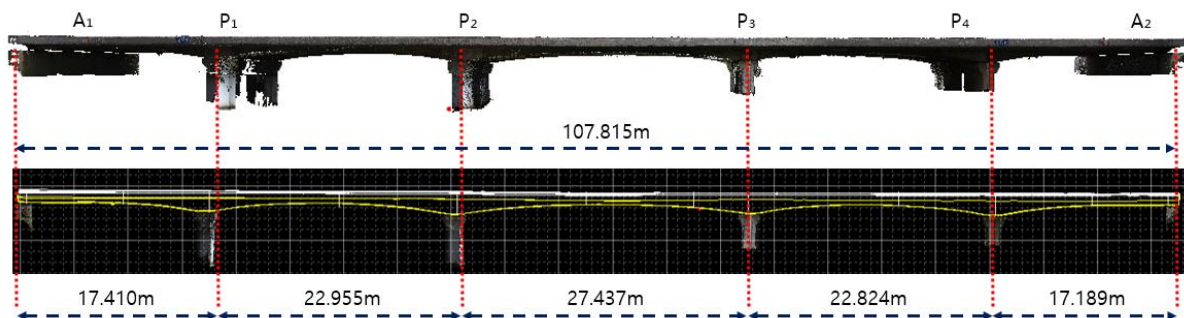
Figure 5: Observation of bridge side dimensions.

To assess the abutments, piers, and overall length of the bridge, the side view of the bridge was observed. Fig. 5 shows the side view of the bridge model. The distances from abutment A1 to A2, including the four piers (P1 to P4), were measured. According to Table 3, while

there were slight variations at the endpoints and minor differences depending on the selection of the piers' central points, the overall measurements were found to be consistent. This consistency indicates that the bridge's structural components align well with the expected design, confirming the bridge's integrity in terms of length and positioning of its abutments and piers.

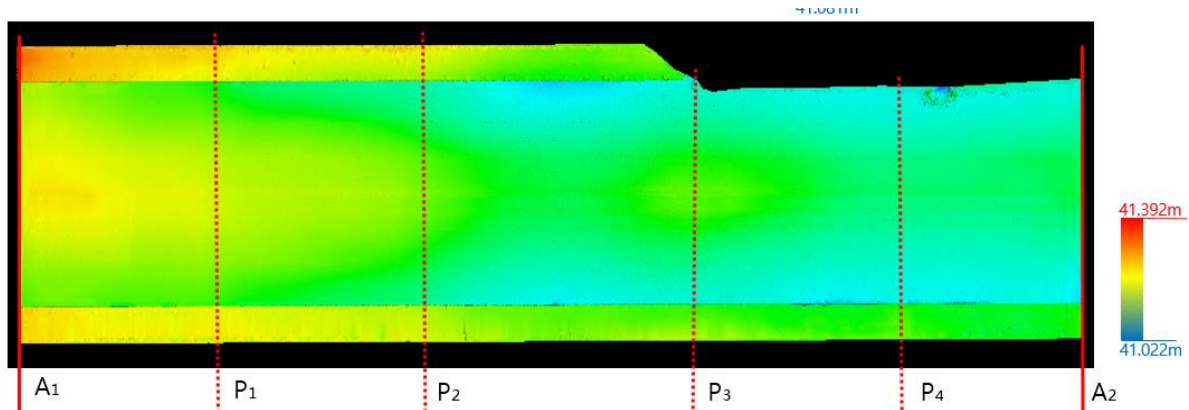
Figure 6: Bridge top view slope analysis.

Overall, it was observed that the abutment A1 at the top left of Fig. 5, where the collapse occurred, is elevated, and the elevation decreases towards the collapse site. Additionally, when comparing both sidewalks, the height of the sidewalk near the collapse site (the top of Fig. 7) is higher than that of the opposite side. The bridge's overall elevation ranges from approximately 41.02m to 41.39m.

Previously, the cross-sectional analysis indicated a thickness difference of about 2cm between abutments A1 and A2. This suggests that the ground level at the left side of Fig. 6,

where abutment A1 is located, is higher than that at the right side, near abutment A2. This difference in elevation might have contributed to the structural variations observed in the bridge, offering a potential explanation for the collapse. The collapse of the Jeongja Bridge is attributed to the bond strength between the concrete at the base and the cantilever reinforcement. Therefore, in this study, the slope of both sidewalks of the bridge was observed. The sidewalks are designed with a 2% slope from the inside to the outside for drainage purposes.

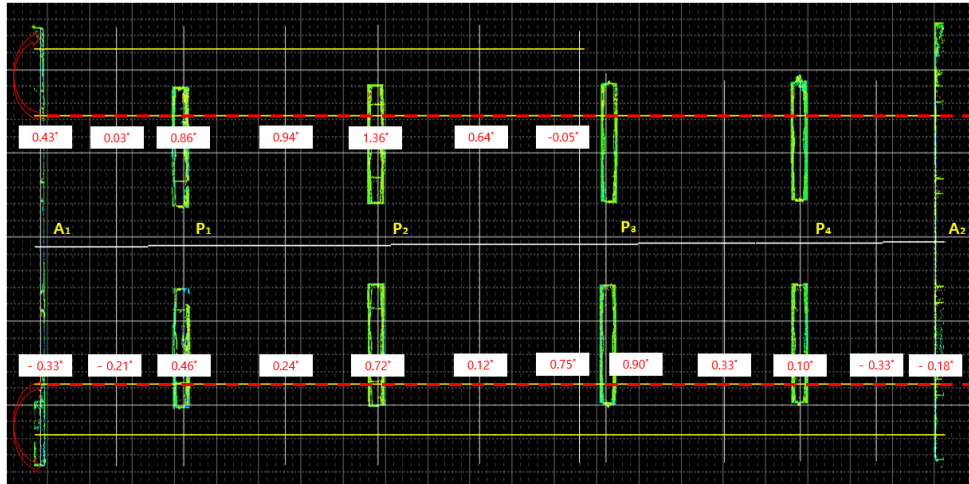
Figure 7: Footbridges slope observation.

Observations from Fig. 7 reveal that the section on the right side, from P3 to A2, is collapsed and thus not available in the current data. Negative values in the observations indicate that the outer part of the sidewalk has sagged more than the inner part. Given that a 2% slope corresponds to approximately  $1.15^\circ$ , the data confirm that the outer part of the sidewalk has experienced a general downward displacement. Furthermore, it was noted that the section just before the collapse and the opposite abutments A1 and A2 experienced slightly more displacement compared to other areas.
