Castle Investigation Using UAV LiDAR Surveying

¹ Nakanihon Air Co., Ltd. Japan

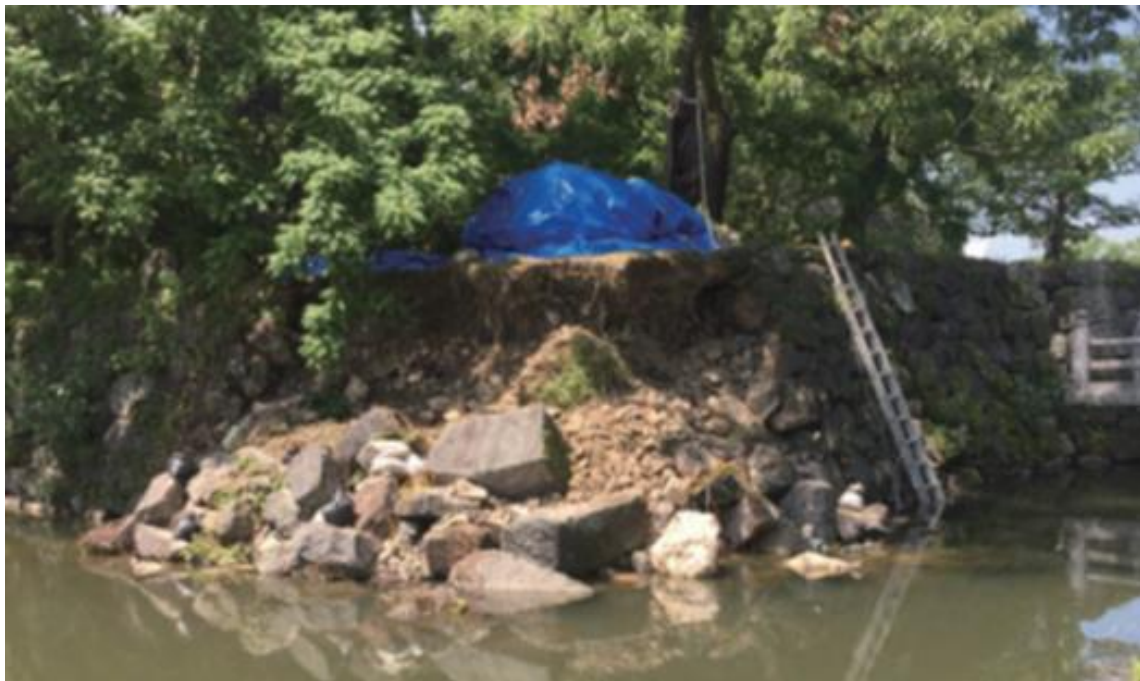
Figure 3: condition of the collapsed stone wall at the bridge gate

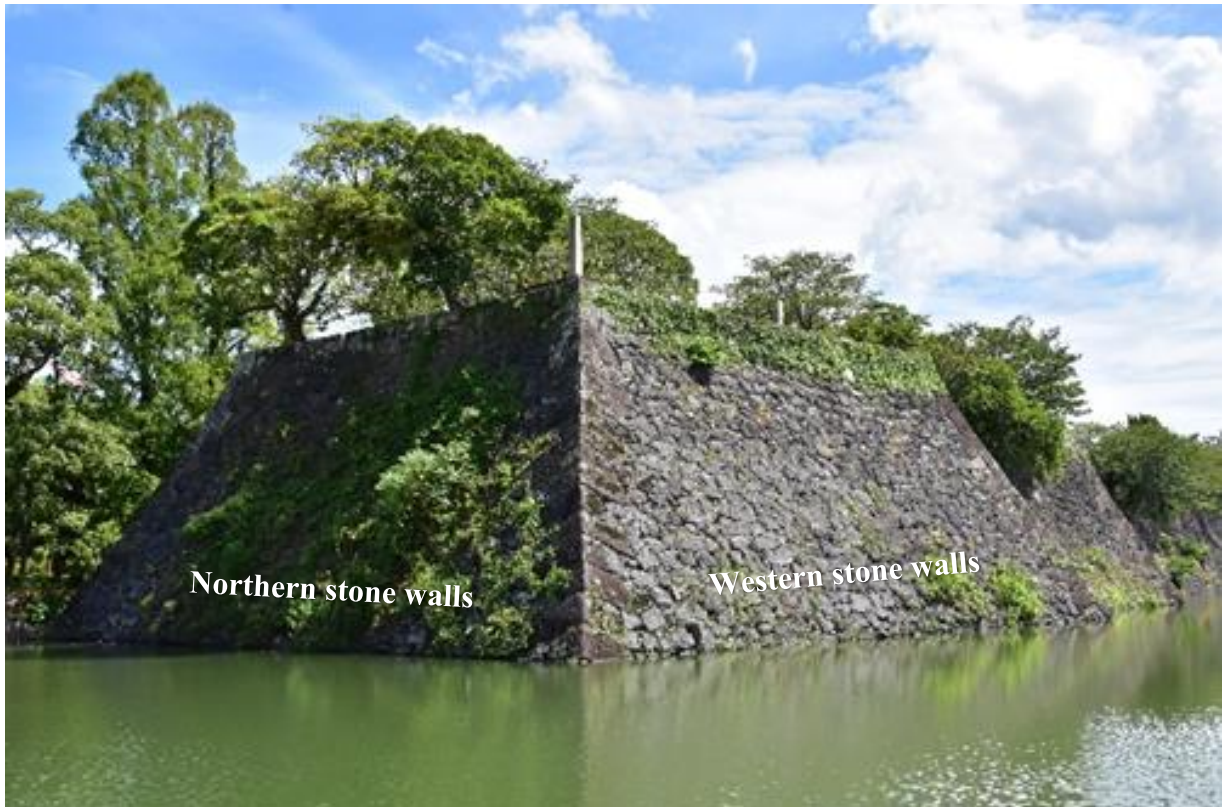
Figure 4: Stone walls at the Main tower foundation

During post-earthquake inspections, it was pointed out that there were bulges in the northern stone walls of the main tower foundation. Although the post-earthquake plan views, elevation drawings, and sectional drawings of the stone walls did not confirm any clear bulges, the expected curvature of the stone walls was not observed on the east side of the northern stone walls. Therefore, UAV laser surveying was conducted to obtain high-density and high-precision 3D point cloud data from the air in an attempt to understand the 3D shape of the stone walls.

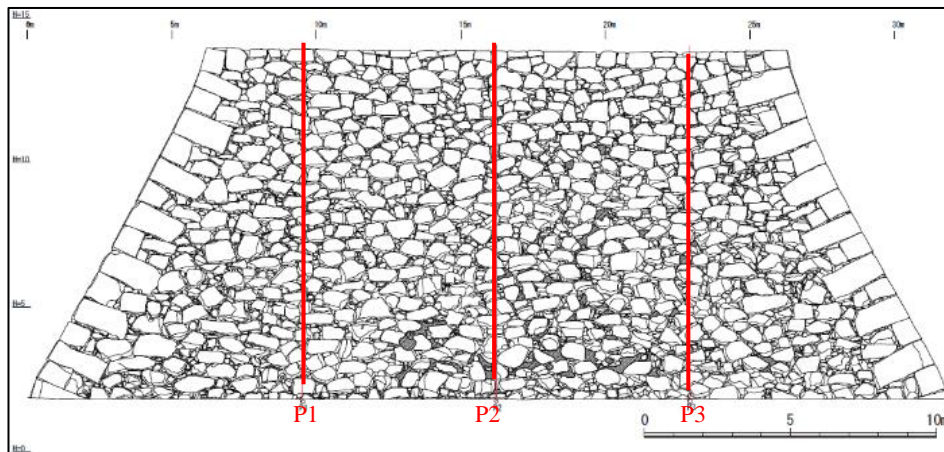
Figure 7: Elevation of the Northern Stone Walls of the Main tower foundation

Using UAV laser data and elevation/sectional drawings, the post-earthquake shape of the northern stone walls of the main tower foundation was analyzed. The shapes from the measured cross-sections surveying by hand and UAV laser data matched well (elevated areas in the laser data were affected by vegetation).

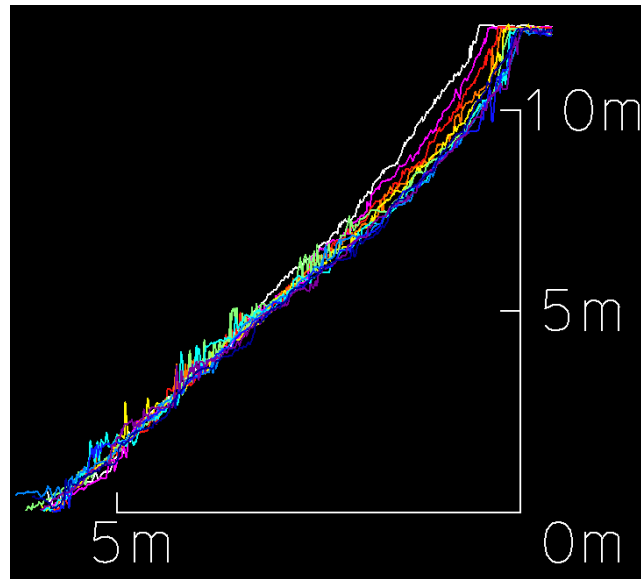
Cross-sections were created from the UAV laser data at fine intervals (2m). In Figure 9, the color of the cross-section lines indicates that white and warm colors are on the east side (P1 side), and cool colors are on the west side (P3 side). When overlaying the cross-

sections, it was observed that the slope is gentler on the west side (cool colors) and becomes steeper towards the east side (white and warm colors).

Figure 9: Overlay of laser Cross-Sections of the northern wall of the Main tower foundation
(Horizontally Exaggerated 2x)

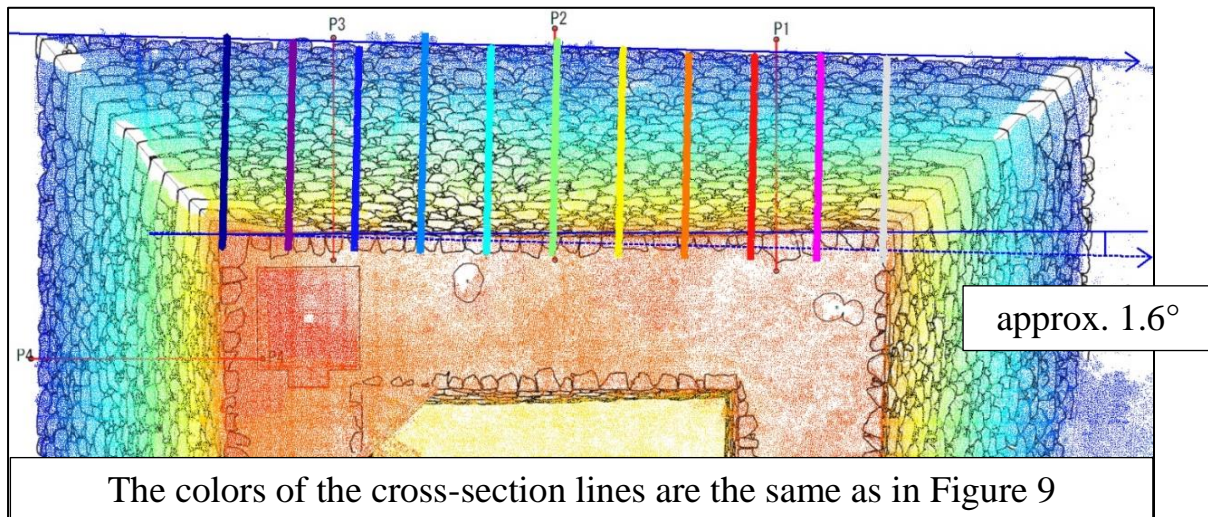
Figure 10: Floor plan of the Northern wall of the Main tower foundation

Reviewing the drawings in Figure10, it was confirmed that the capstones and base stones are tilted approximately 1.6 degrees from parallel, narrowing towards the east side (P1 side). Since the height of the stone walls remains almost constant, the slope becomes steeper as the width narrows towards the east side.

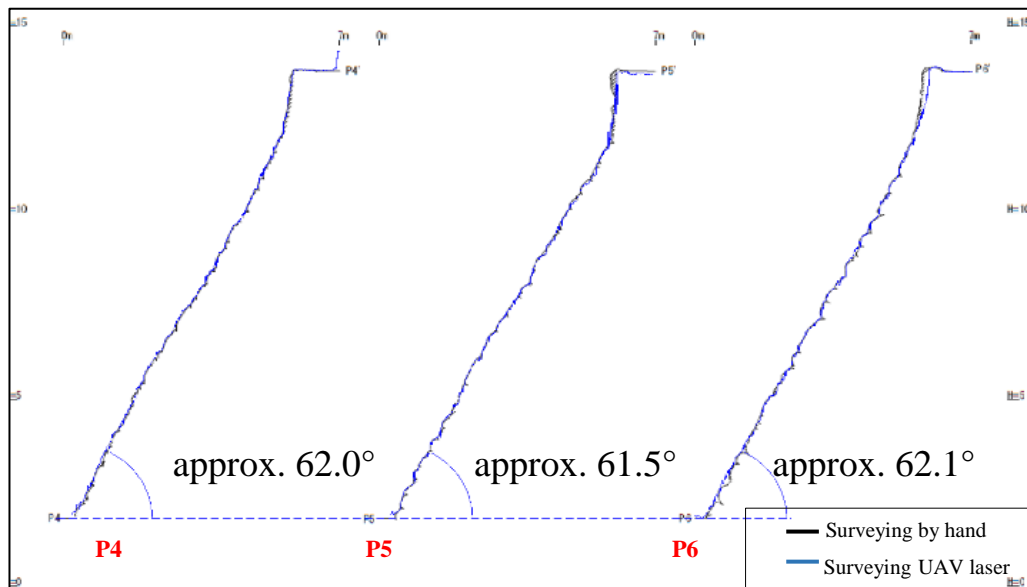
Figure 12: Sectional Drawings of the Western Stone Walls of the Main tower foundation

No significant distortions like those in the northern stone walls were observed in the plan of the western stone walls. The sectional drawings showed relatively uniform slopes, though the central slope was slightly gentler compared to the sides. Therefore, a more

detailed analysis was conducted focusing on minor bumps (bulges) in the western stone walls.

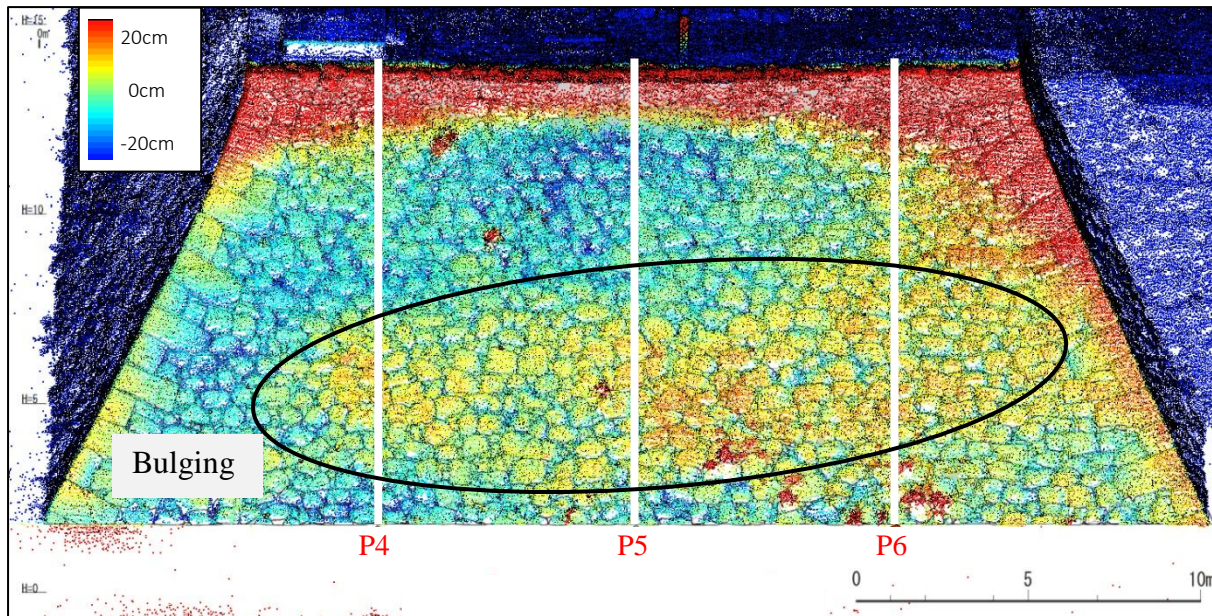
Figure 13: Bumps Plan of the Western of the Main tower foundation

Figure 13 represents the bumps of the western stone walls. The average slope is shown in green, convex areas in warm colors (red: convex by 20cm or more), and concave areas in cool colors (blue: concave by 20cm or more). Viewed as a whole, the lower part of the western stone walls shows a slight bulging. Although this may not be easily discernible from the cross-sectional drawings alone, comparing the cross-sectional drawings in Figure 12 with those in Figure 13 reveals that the lower part also shows bulging in the P4 and P5 cross-sectional drawings.

While the distortions in the northern stone walls and bulges in the western stone walls of the main tower foundation are newly confirmed this time by high-density data from UAV laser scanner, it is unclear whether they were caused by the 2016 Kumamoto Earthquake. However, detail studies of their shapes help for the preservation of cultural properties and the formulation of restore plans as needed. Although this analysis focused on the stone walls of the main tower foundation, the data was collected comprehensively, and further analysis might reveal new findings in other areas.
