## The comparison of the damaged houses estimation method caused by heavy rainfall in July, 2020 Kuma river flood and heavy rainfall in August, 2021 in Rokkaku river flood using aerial photographs and inundation simulation

**Keywords:** Aerial Photograph, August 2019 Rokkaku river flood, July 2020 Kuma river flood, Inundation simulation, Damaged house estimation

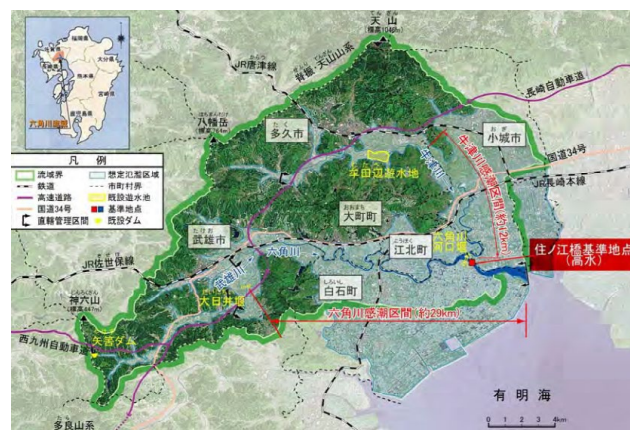
Figure 1: Watershed map of the Rokkaku River

The Rokkaku River watershed is surrounded by hilly mountainous terrain, and the Shiraishi Plain extends downstream. The riverbed gradient is approximately 1/60 in the upper reaches, 1/150-1/1,000 in the middle reaches, and 1/1,500-1/45,000 in the lower reaches. A major characteristic of the Ariake Sea is the relatively long tidal zone (29

In this study, two cases of flood damage were analyzed and compared: the first was the Rokkaku River flood damage caused by the August 2019 torrential rainfall. Figure 1 shows a map of the Rokkaku River basin.

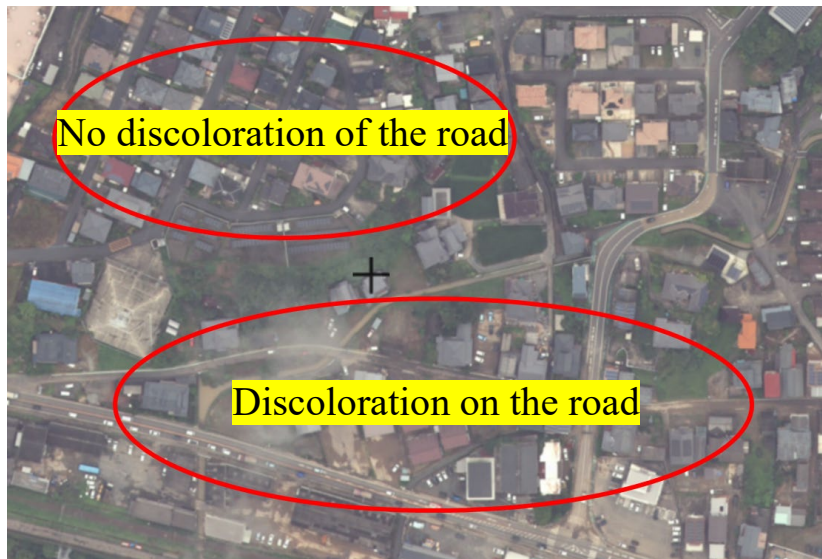
Figure 4: Aerial view of the Rokkaku River flooding

First, we attempted to extract the inundation area using aerial photographs published by GSI and helicopter videos published by MLIT on YouTube channel. The aerial photographs published by GSI (Figure 4) were taken on August 30, two days after the peak of the flooding, so the floodwaters had receded. Although it is not impossible to distinguish between flooded and non-flooded areas by the presence or absence of road discoloration, we investigated images other than GSI's aerial photographs because of the risk of misjudging the extent of flooding.

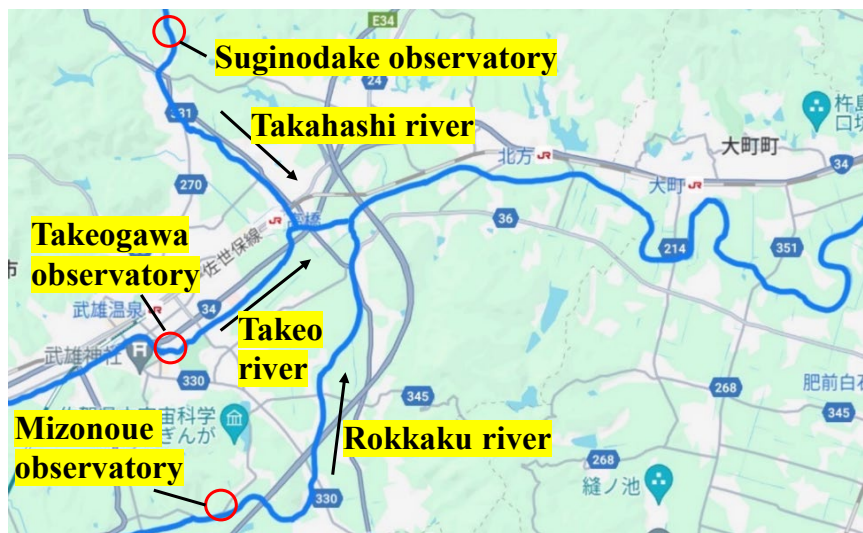
Figure 10: Location map of water level and rainfall observation stations

Three rivers were considered for the flow: the main Rokkaku River, and the Takeo and Takahashi Rivers, which are particularly large tributaries of the Rokkaku River. The locations of the rivers and the observatories are shown in Figure 10. For the Rokkaku River, a hydrograph was created using data from the Mizonoue observatory upstream, and for the Takeo River, data from the Takeo River observatory upstream (Figure 11). The Takahashi River hydrograph was created using rainfall data from the Suginodake rainfall observatory located in the river basin and iRIC's SRM (a solver that can calculate hydrographs from rainfall data) because there was no flow observatory upstream (Figure 11). In order to reproduce internal flooding, rainfall was applied to the entire computational grid. The rainfall data was measured at the Takeo river observatory closest to the target area from 0:00 to 12:00 on August 28, 2019 (Figure 11).

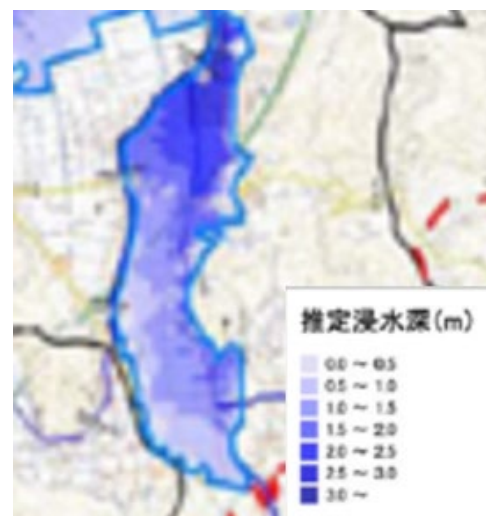
Figure 19: Flooding situation map

The results for the maximum inundation depth in the upper reaches of Takeo City are shown in Figure 18. Compared to the inundation map published by the Takeo River Office (Figure 19), the approximate extent of inundation and the distribution of inundation depths in the upper reaches of Takeo City were consistent.

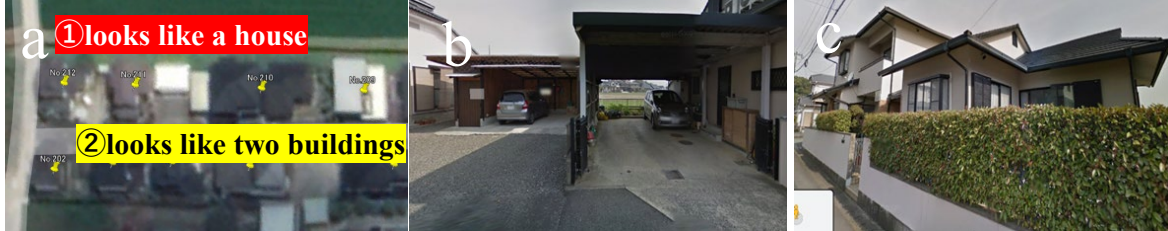
Figure 20: Identification of houses “a”) Before enlargement “b”) ① Carport easily misidentified as “a” house (red area in “a”) “c”) General house (orange area in “a”)

Google earth Pro and Google Map Street View were used to locate houses. First, we switched to the Google earth Pro pre-flood image (April 27, 2019, etc.) to identify houses located within the flood zone. Figure 20a) is a portion of the image. In (1), there appears to be a house, and in (2), there appear to be two houses. However, when viewed from the street view, (1) is actually a carport (Figure 20b) and (2) is actually one large house (Figure 20c). Thus,

there was a risk that the houses could be mistakenly identified from an aerial view, so we used Google Map Street View of the same location as a supplemental method to identify the location of the houses.

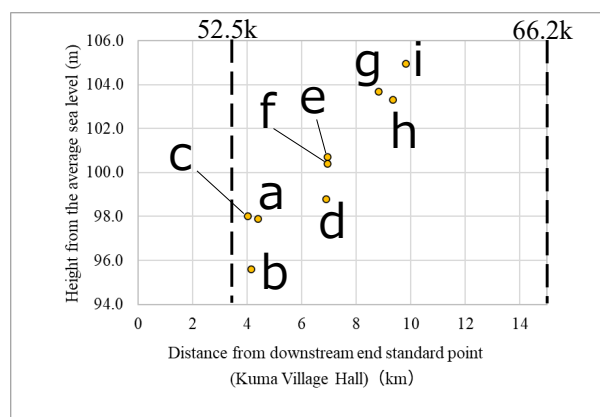
Figure 27: Ground elevation at the edge

The results of the Kuma River inundation simulation are described below. The peak time of the Kuma River flooding is estimated to be around 9:42 a.m. on July 4, around the Aoiaso Shrine. Aerial photographs 2 and 4 are close to the area of maximum inundation, and aerial photograph 3 was taken approximately six hours after the peak of inundation. Figure 27 shows the location information, ground elevation, and distance from the reference point (Kuma Village Office) of 10 measurement points read from the five aerial photographs. Figure 27 shows that the maximum difference in inundation level at the edge of the target area of approximately 8 kilometer is 9.3 meters (maximum value: 104.9 meters - minimum value: 95.6 meters).

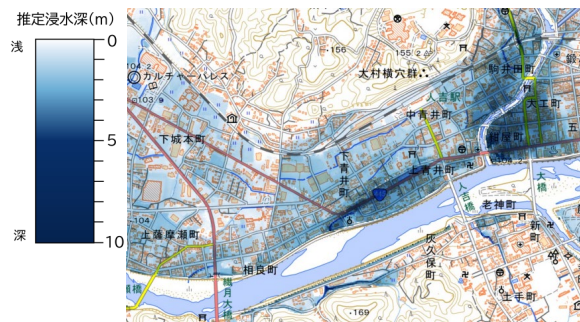
Figure 31: Hitoyoshi urban area (Figure 30 enlarged)

Figure 28 shows the results of the maximum inundation depth calculations. In the urban area of Hitoyoshi city, the inundation depth was 1 to 2 meters. The actual calculation time was 77.5 minutes. The actual calculation time was 77.5 minutes. Compared with the GSI's inundation estimation map (Figure 30), the inundation area and depth were generally reproduced. Figures 29 and 31 show enlarged images of the Hitoyoshi urban area (yellow box) in Figures 28 and 30, respectively. Of the 3572 houses in the inundation simulation area, 2891 were inundated. Figure 32 shows a contour plot of the maximum flow velocity at intervals of 1 m/s. The red boxes in Figures 28 and 32 indicate the area covered by the GSI data (Figure 30).

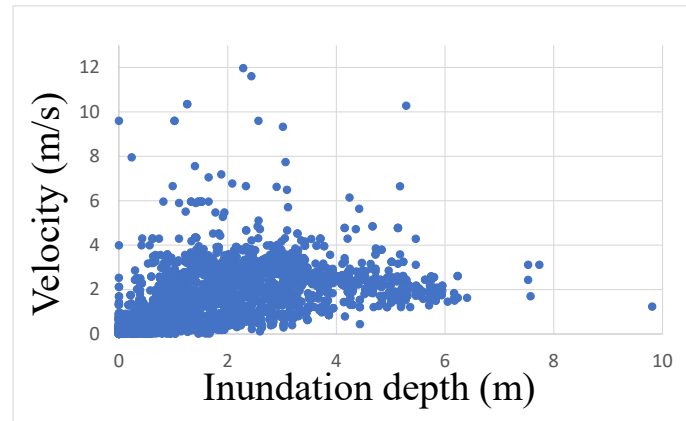
Figure 33: House locations within the inundation area

Figure 33 shows the relationship between inundation depth and flow velocity for each of the 2891 houses within the inundation area based on the inundation simulation results. Previous studies have classified damaged houses as partially or totally destroyed based only on the estimated inundation depth, but in this study, the correlation between inundation depth and flow velocity was found to be weak (correlation coefficient 0.508), so the number of damaged houses was classified based on the maximum flow velocity and the number of houses at the maximum flow velocity of 0.1 meter pitch was calculated. The classification results are shown in Figure 36. The total number of damaged houses according to the Hitoyoshi City data was 2,662, of which 2,643 were subject to the inundation simulation. Comparison of the two data sets shows that the velocity classification of Hitoyoshi City is generally consistent with the published data, with total destruction classified as having a velocity of more than 2.4 m/s, large partial destruction as more than 1.7 to less than 2.4 m/s, partial destruction as more than 0.4 to less than 1.7 m/s, and partial damage as less than 0.4 m/s. From the viewpoint of simpler estimation, we focused on the maximum flow velocity for each mesh for each house in the entire inundation area rather than examining the complex fluid forces acting on each house individually, and evaluated the effectiveness of this method as a method to quickly grasp the damage situation and classify each damage. The location information for each damaged house is not publicly available, so it is difficult to obtain the breakdown shown in Figure 33. In order to improve the accuracy of damage assessment, it is necessary to clarify the relationship between the damage to individual houses and the hydrodynamic forces acting on them as a future task. The hydrodynamic forces are expressed in terms of the depth of inundation, flow velocity, density of soil particles, and reaction

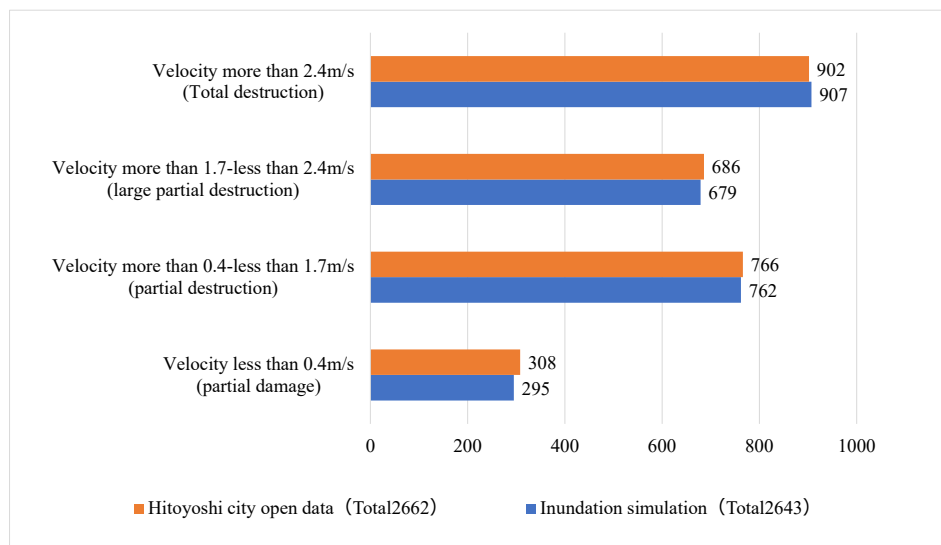
Figure 34: Optimal flow velocity for the number of damaged houses in Hitoyoshi City

inundation map by GSI, and the number of damaged houses in Hitoyoshi City generally agreed with the data published by Hitoyoshi City, where the flow velocity was 2.4 m/s or higher for total destruction, 1.7 to 2.4 m/s or lower for large partial destruction, 0.4 to less than 1.7 m/s for partial destruction, and 0.4 m/s for partial damage. The proposed method, which includes the effect of flow velocity, has the potential to be an effective method of surveying damaged houses. However, since the durability of houses depends on the structure and age of the houses, the effect of flow velocity may be smaller in rivers with different river gradients and inundation patterns, it is necessary to confirm the relationship between inundation depth and flow velocity in other inundation cases. Therefore, it is necessary to confirm the relationship between inundation depth and flow velocity in other inundation cases. In the future, it is necessary to extensively study the improvement of estimation accuracy to establish a methodology for advanced survey methods.
