## Collapse Accident Site Investigation using Terrestrial LiDAR Surveying

**Abstract :** *A collapse incident is one of the representative disaster accidents. Collapses can occur due to internal defects during the design phase, but other collapses are caused by natural disasters such as typhoons or heavy rainfall, as many structures are exposed to the environment. Therefore, continuous inspections of structures are crucial. Additionally, investigating the causes and damages of already occurred collapse accidents is necessary for preventing recurrence and post-management. However, dealing with and investigating collapse sites is challenging due to the risk of additional collapses. To overcome these challenges, utilizing terrestrial LiDAR is suitable for conducting on-site investigations in secured locations. This study suggests the approach of using terrestrial LiDAR for collapse site investigations. Obtained scan data for the entire collapse site of Jeongja Bridge, which occurred on April 5, 2023, using terrestrial LiDAR. LiDAR measurements were performed at 13 locations to acquire data for the upper and side portions of the bridge. The acquired data was integrated to construct a

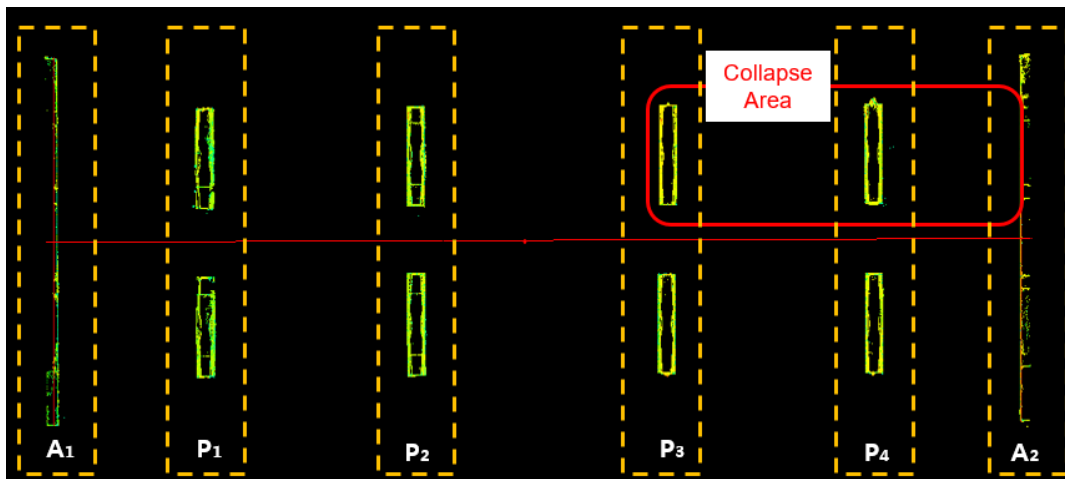
Figure 3: Bridge abutment and pier layout

In Fig. 3, the pedestrian sections near the collapsed piers P3 and P4, and abutment A2 could not be assessed due to the collapse caused by the accident. However, the pedestrian section on the opposite side showed minimal differences. Observing the cross-sectional measurements of the pedestrian sections, the length on the left side where the collapse occurred, from A1 to P2, ranged from 3.471m to 3.549m. On the right side, from A1 to A2, the length ranged from 3.544m to 3.643m. Compared to the design plan, which specifies a sidewalk length of 3.5m, the left side showed a deviation of approximately -3cm to +5cm, while the right side showed a deviation of approximately +4cm to +14cm. The observed width of the bridge was between 25.919m and 26.091m, showing a deviation of about -2cm to +9cm from the design width of 26.000m. The measurements indicate that the left-side sidewalk, where the collapse occurred, was closer to the design specifications compared to the right side, and the overall width of the bridge exhibited only minor discrepancies from the design.
