Castle Investigation Using UAV LiDAR Surveying

¹ Nakanihon Air Co., Ltd. Japan

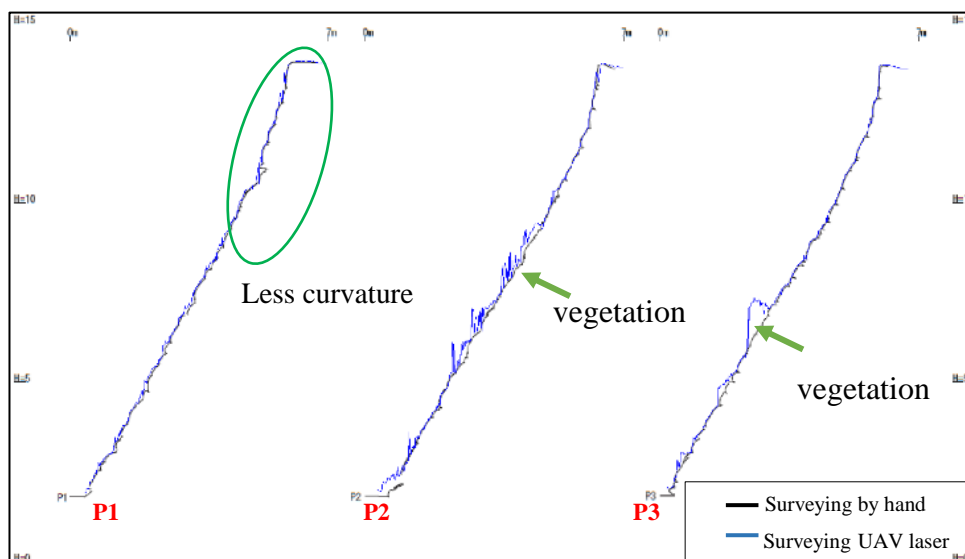
Figure 8: Sectional Drawings of the Northern Stone Walls of the Main tower foundation

Using UAV laser data and elevation/sectional drawings, the post-earthquake shape of the northern stone walls of the main tower foundation was analyzed. The shapes from the measured cross-sections surveying by hand and UAV laser data matched well (elevated areas in the laser data were affected by vegetation).

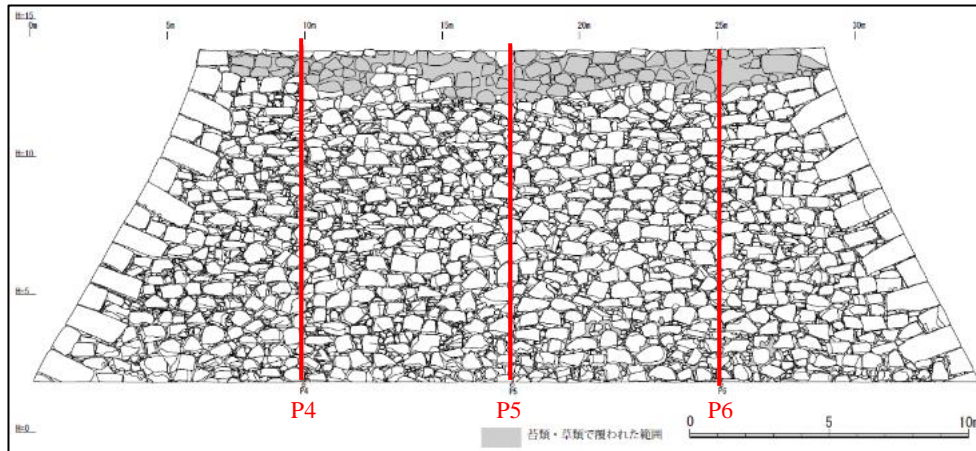
Figure 11: Elevation of the Western Stone Walls of the Main tower foundation

No significant distortions like those in the northern stone walls were observed in the plan of the western stone walls. The sectional drawings showed relatively uniform slopes, though the central slope was slightly gentler compared to the sides. Therefore, a more

detailed analysis was conducted focusing on minor bumps (bulges) in the western stone walls.
